# Debris/Ice/TPS Assessment And Photographic Analysis For Shuttle Mission STS-42

March 1992

National Aeronautics and  
Space Administration

**Gregory N. Katnik**  
**NASA/Kennedy Space Center**

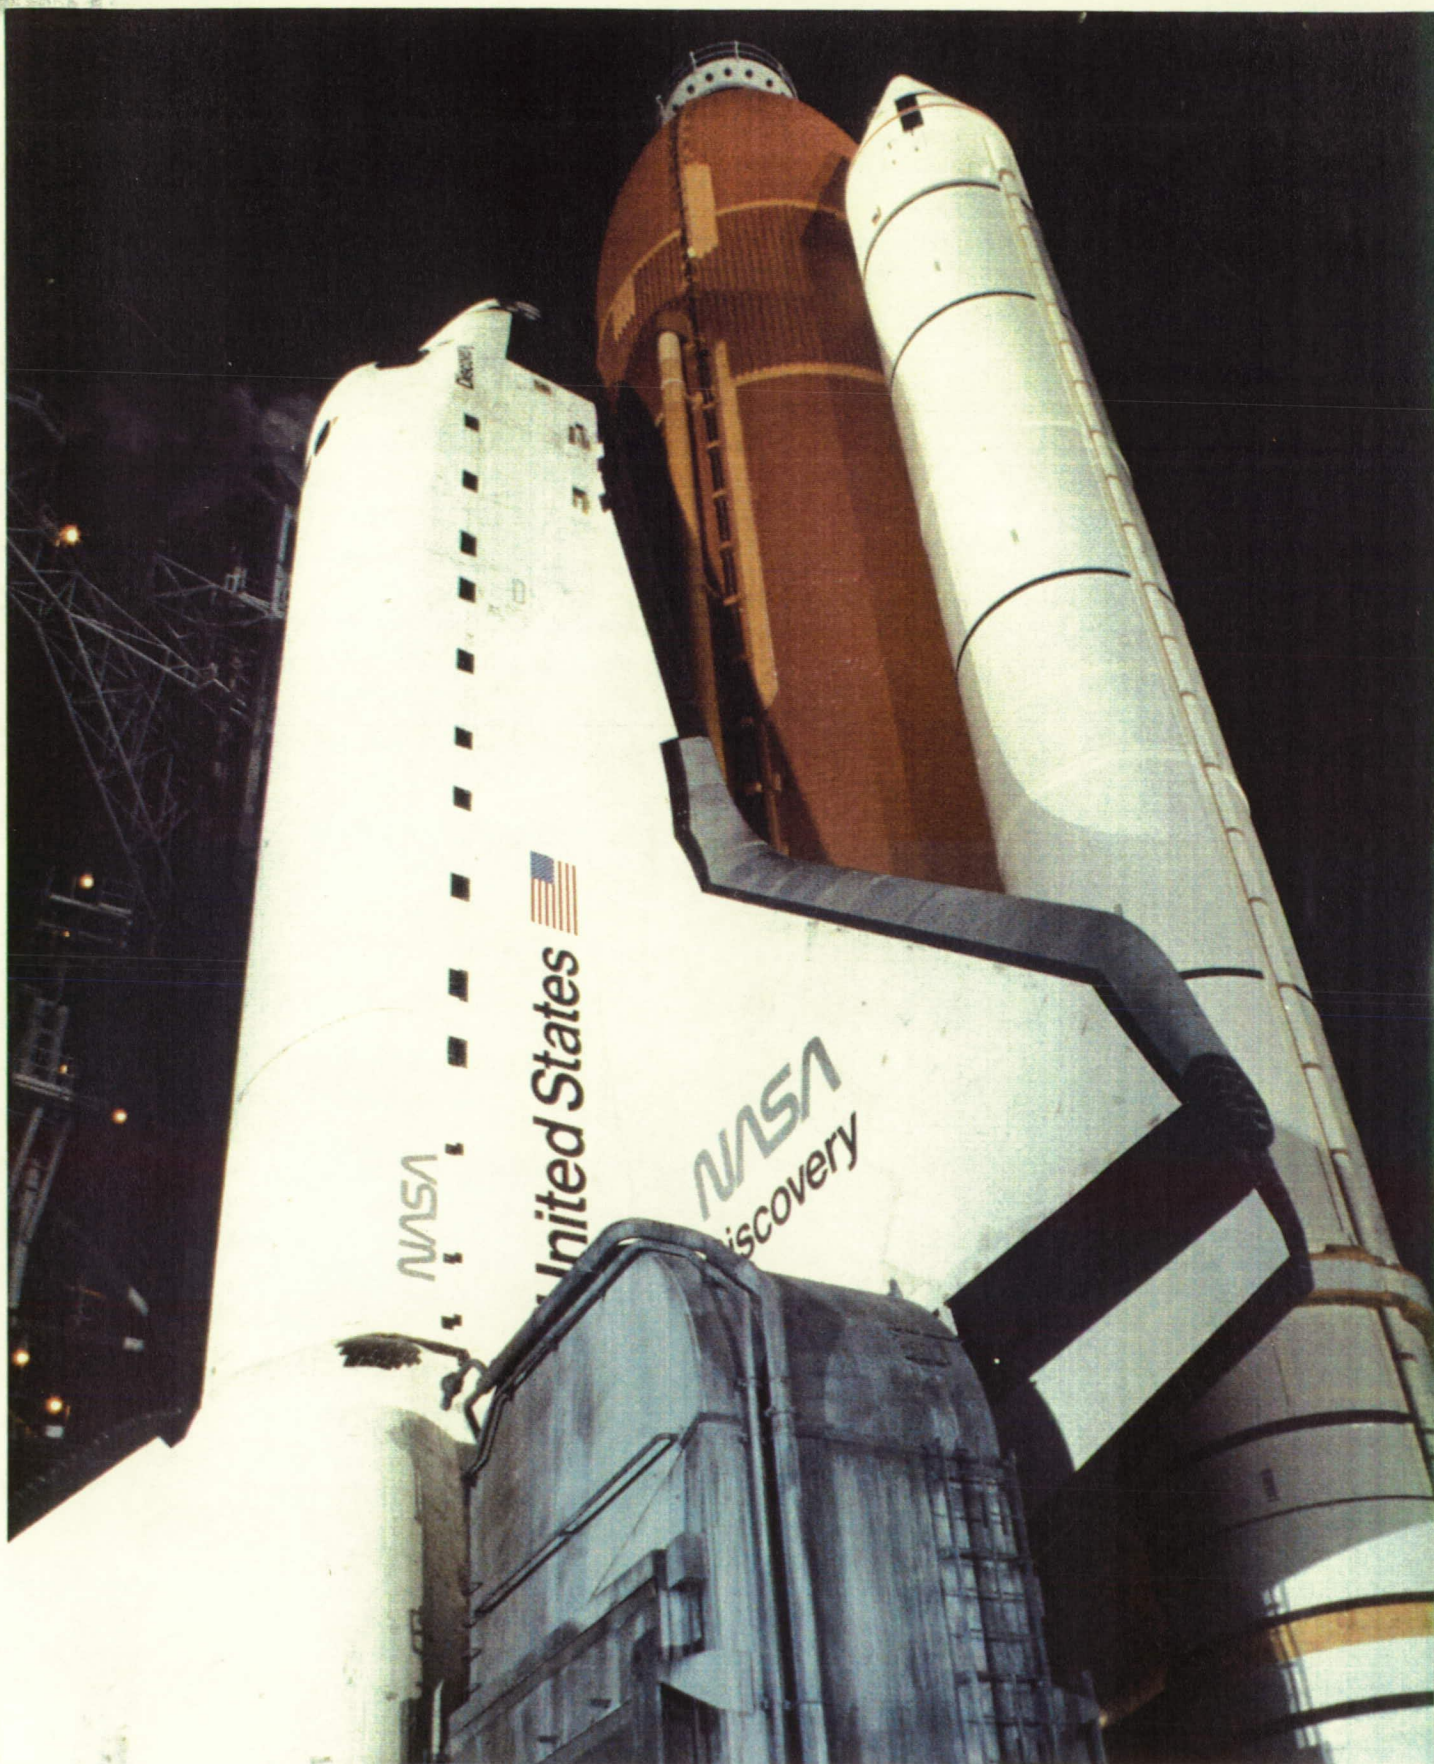
Overall view of OV-103, ET-52 (LWT 45), and BI-048 SRB's. Isolated patches of frost had accumulated on the TPS acreage of the ET LH2 tank.

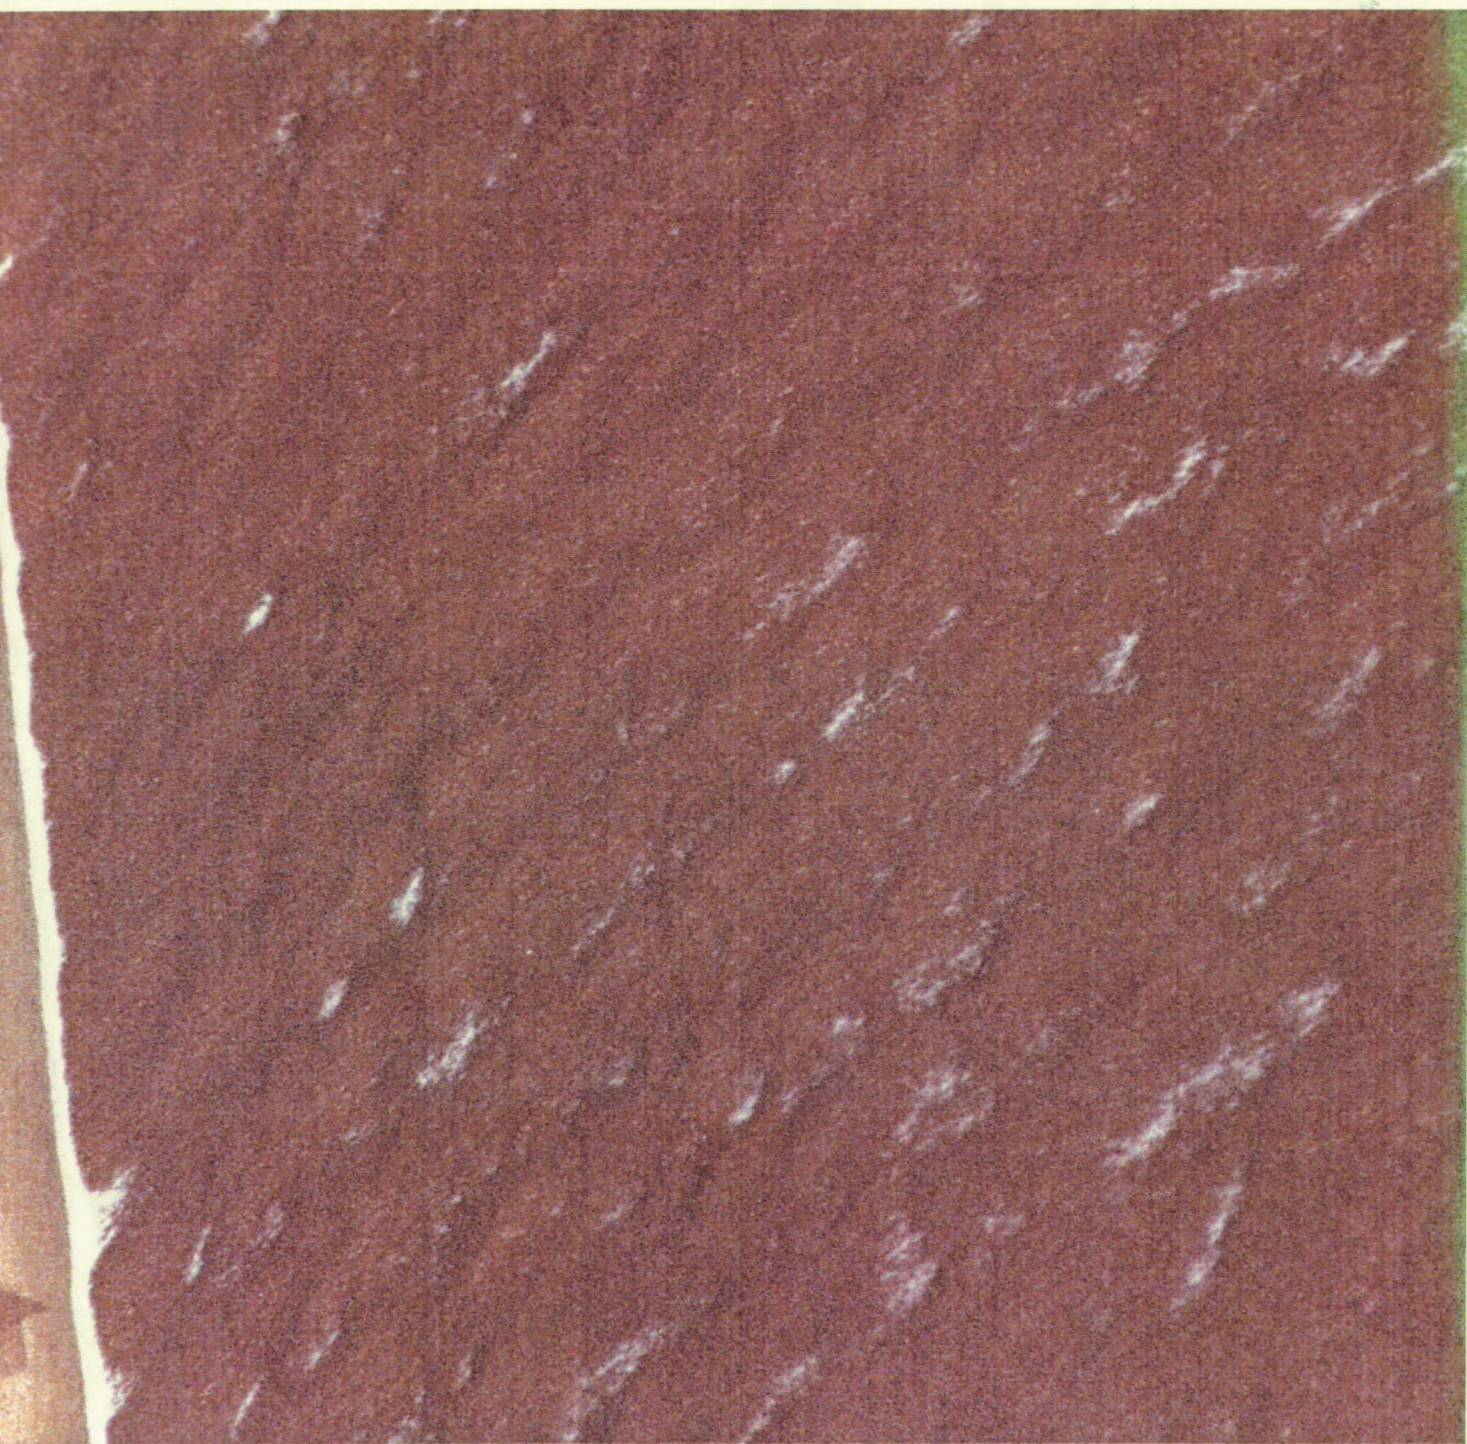
Isolated patches of frost on the ET LH2 tank TPS acreage (+Y+Z quadrant) had melted prior to launch as the ambient temperature increased.

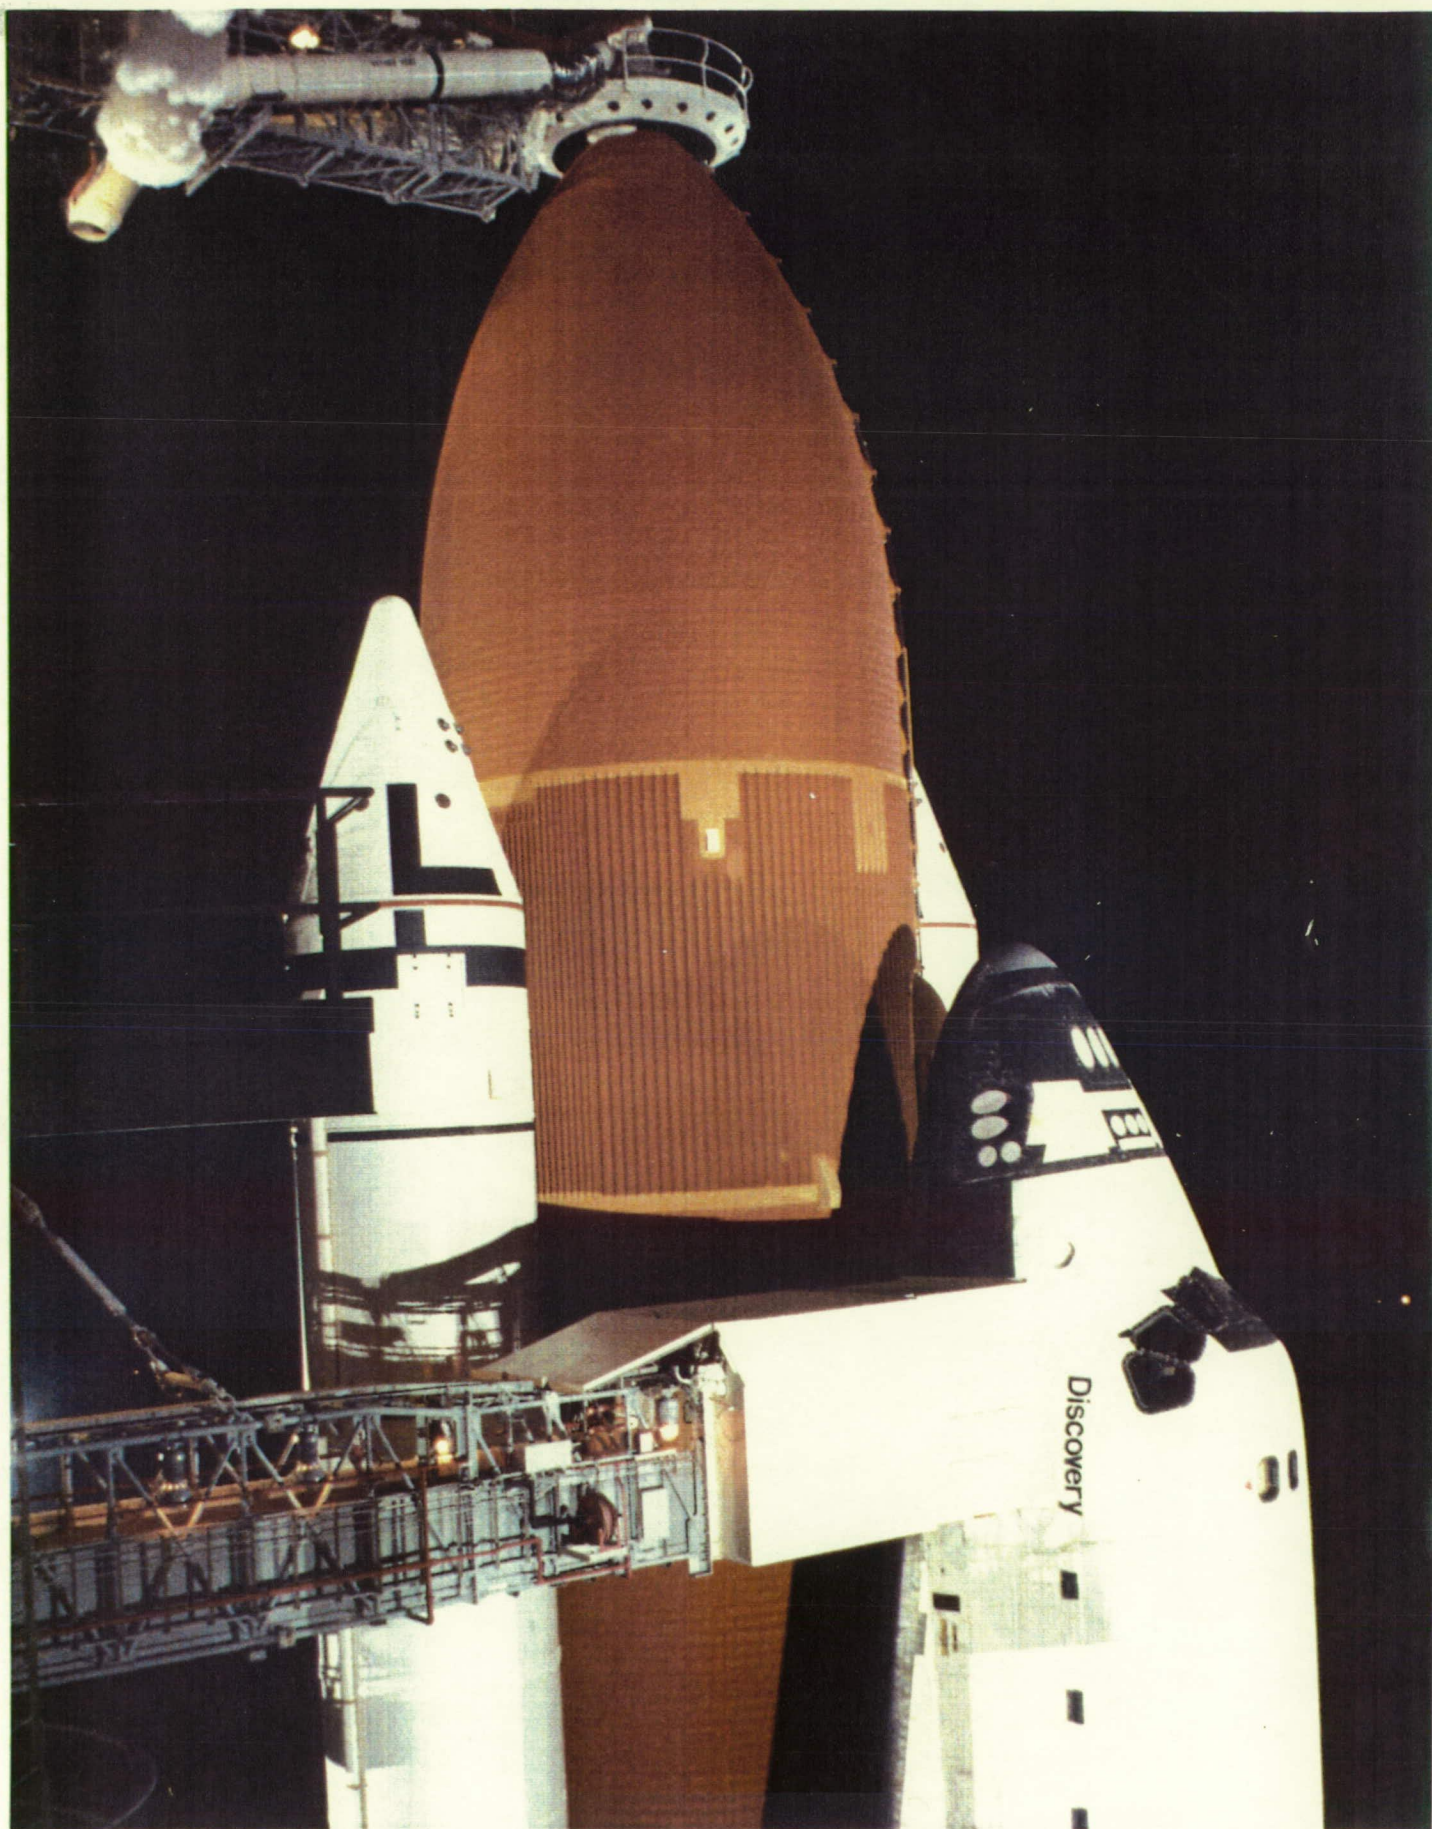
Light condensate, but no ice or frost, had accumulated on the  
ET LO<sub>2</sub> tank

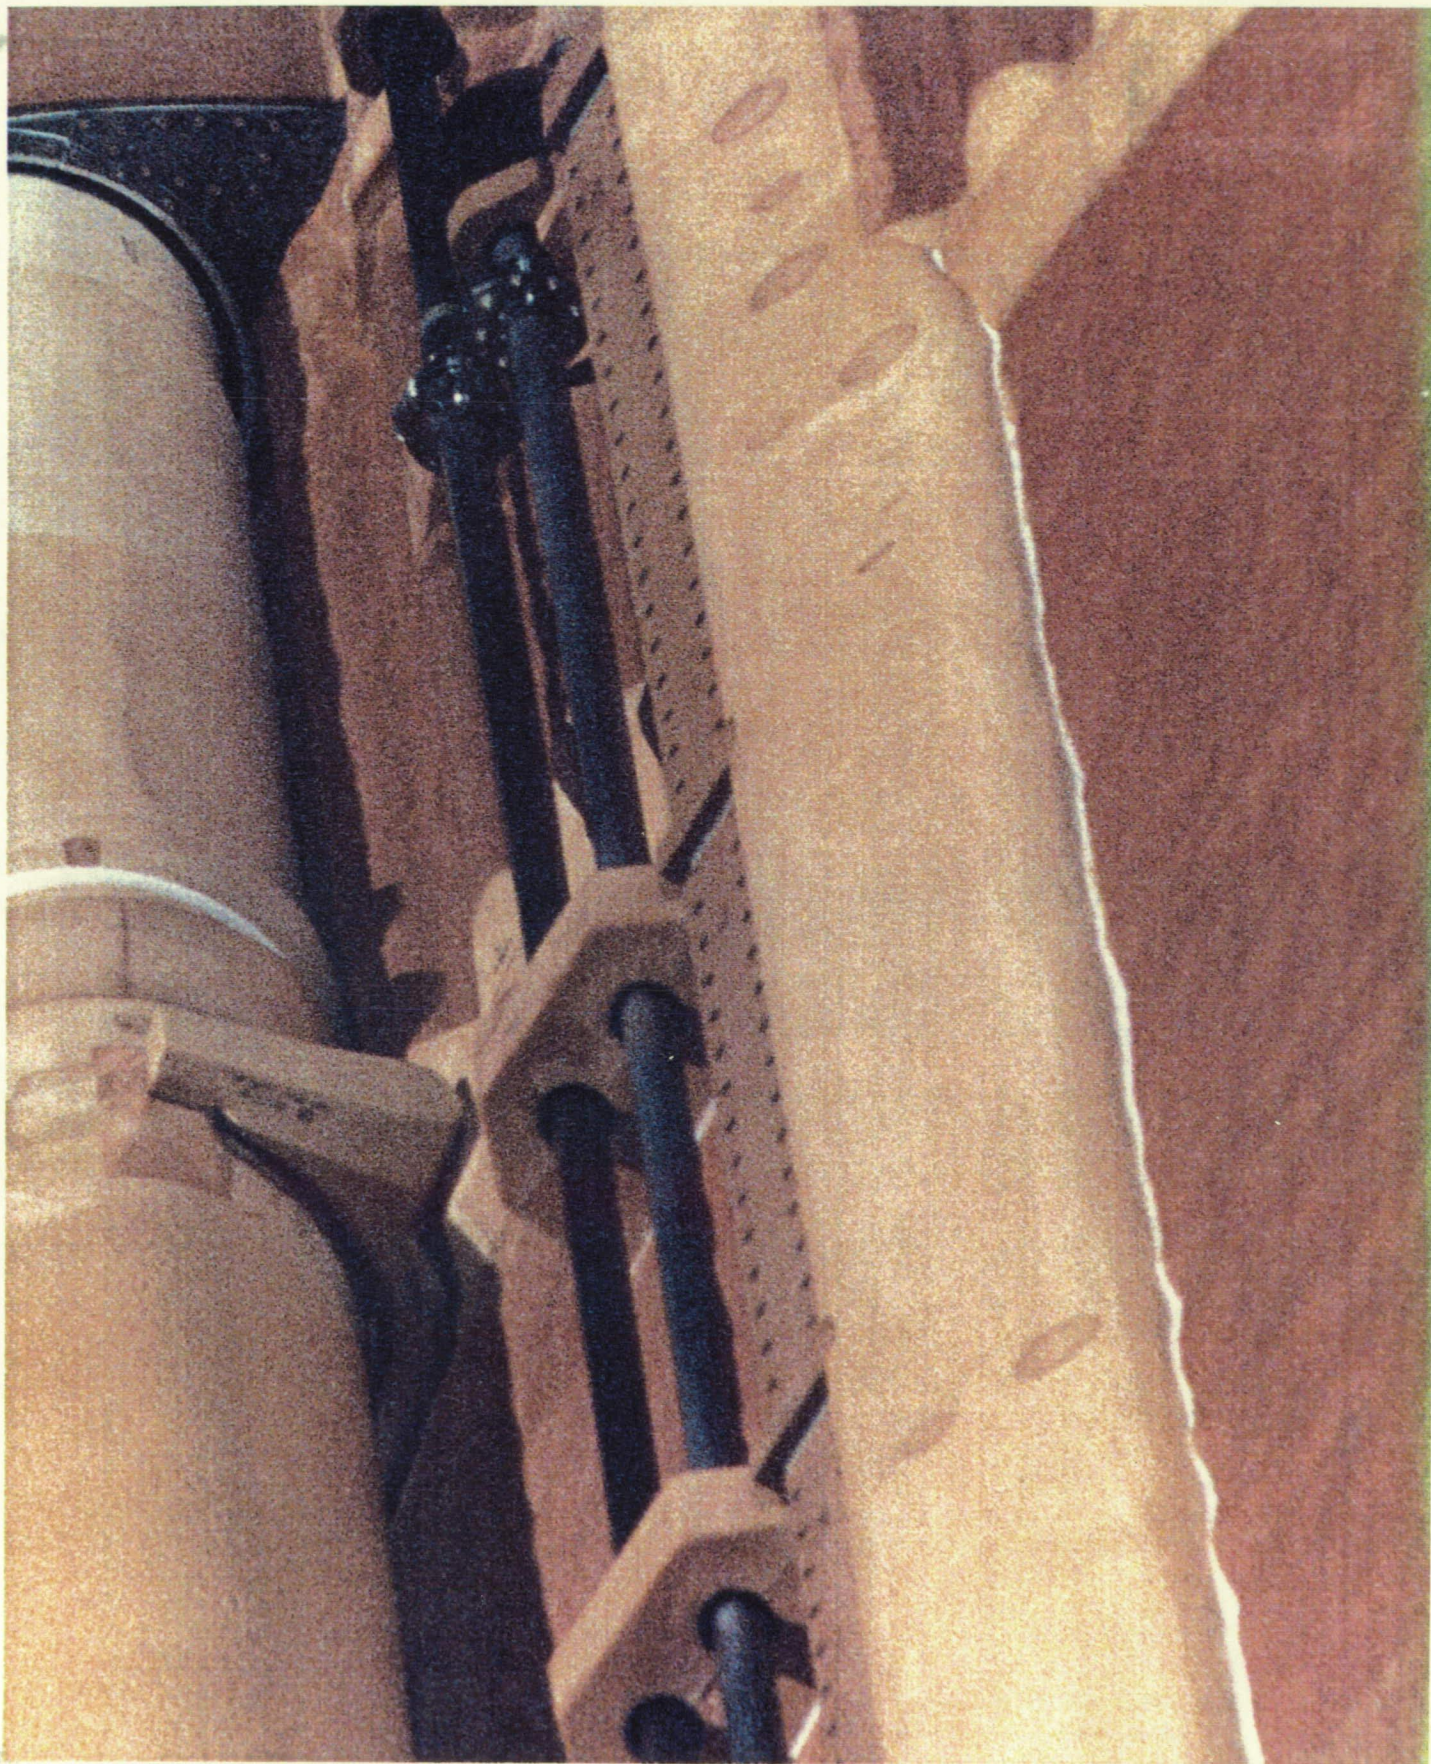
Ice/frost had formed along the bondline of the PAL ramp. Ice/frost accumulations in the L02 feedline support bracket and upper bellows were acceptable per the NSTS-08303 criteria.

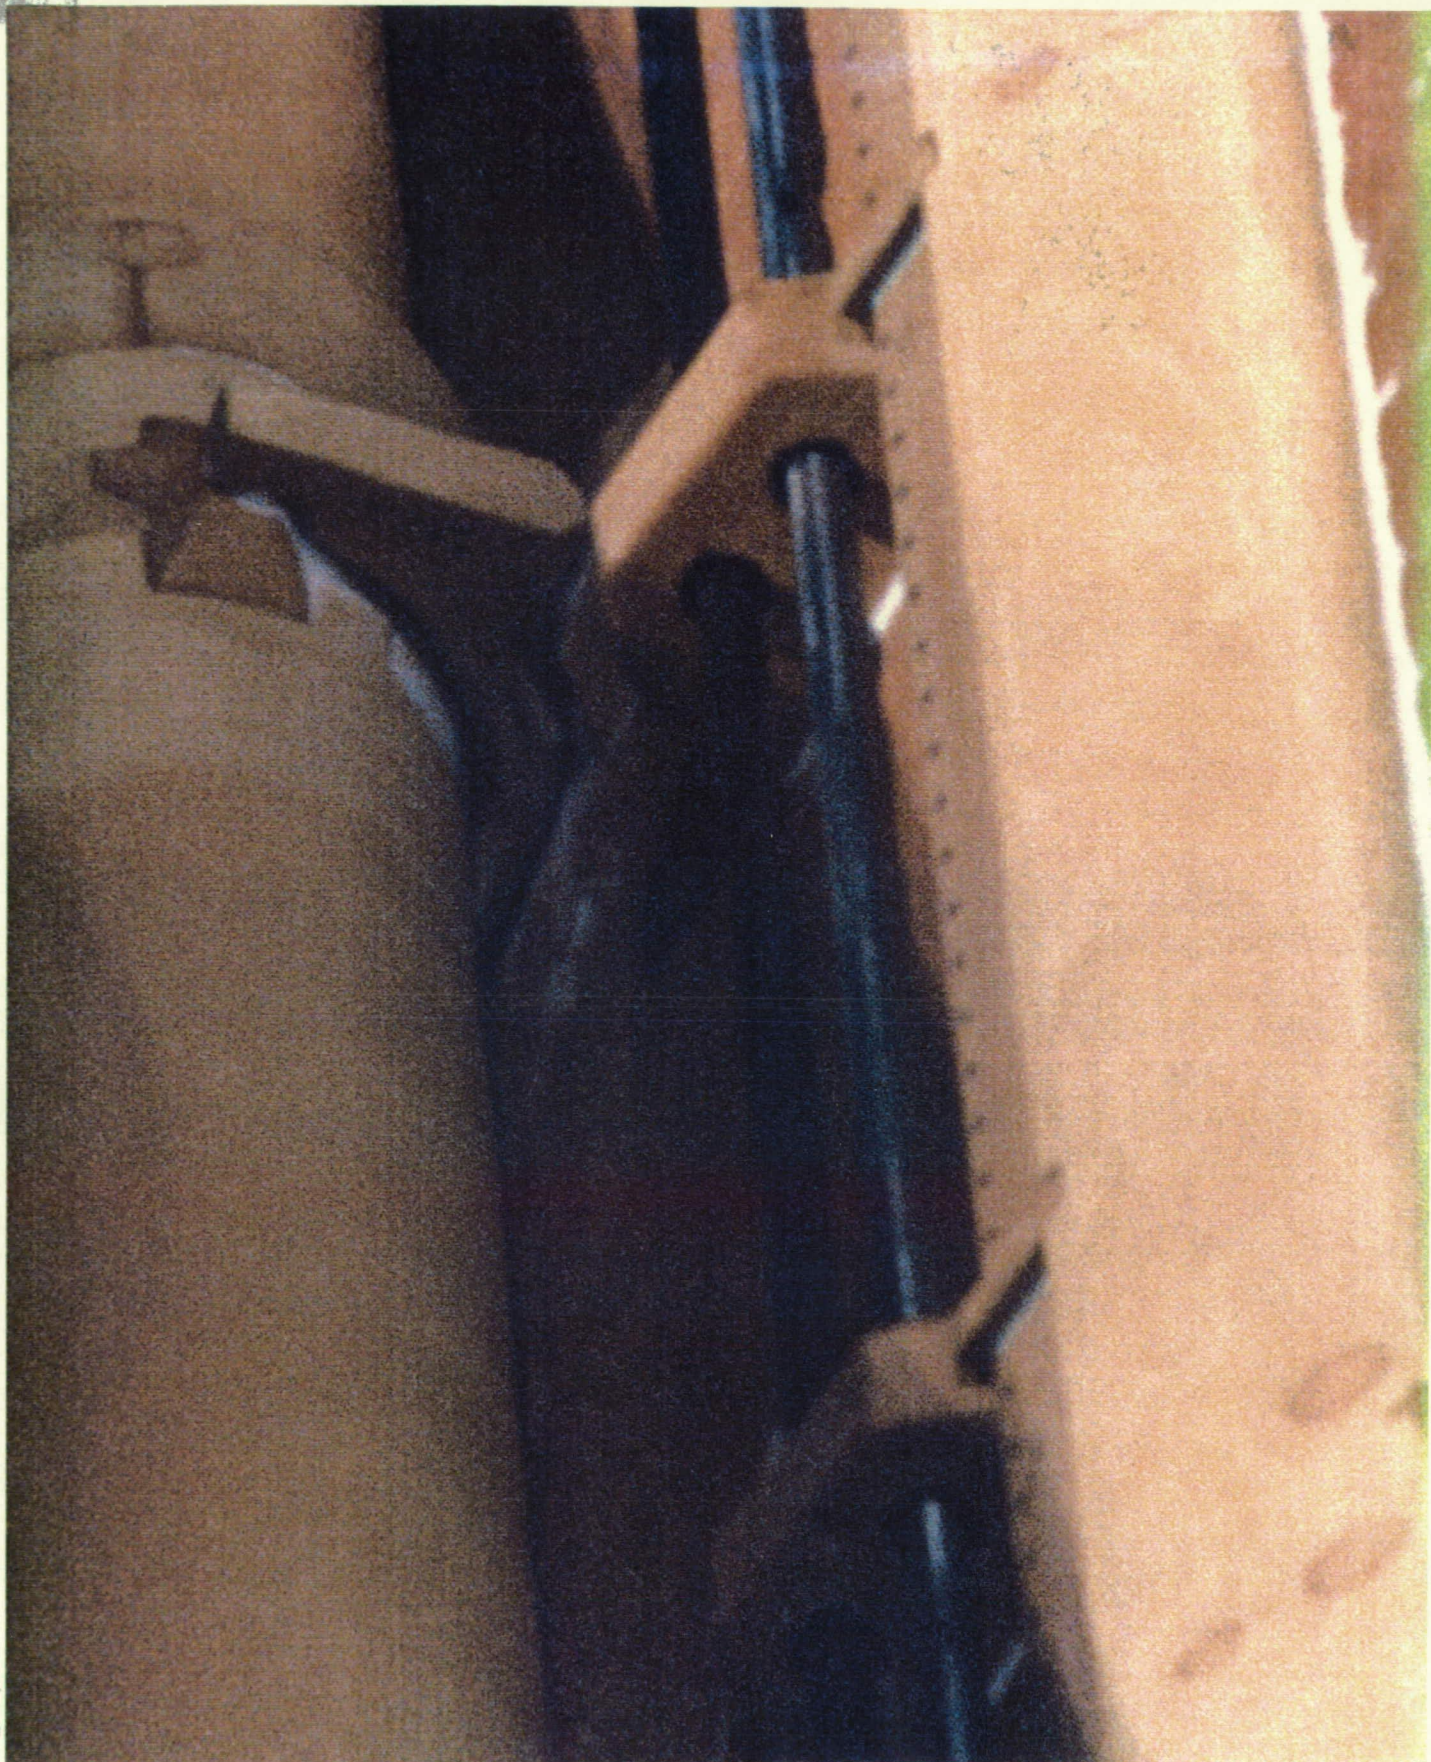
Ice/frost accumulations on the LH2 tank acreage and along the PAL ramp had melted prior to launch. Ice/frost formations in the LO2 feedline support brackets were acceptable per the NSTS-08303 criteria.

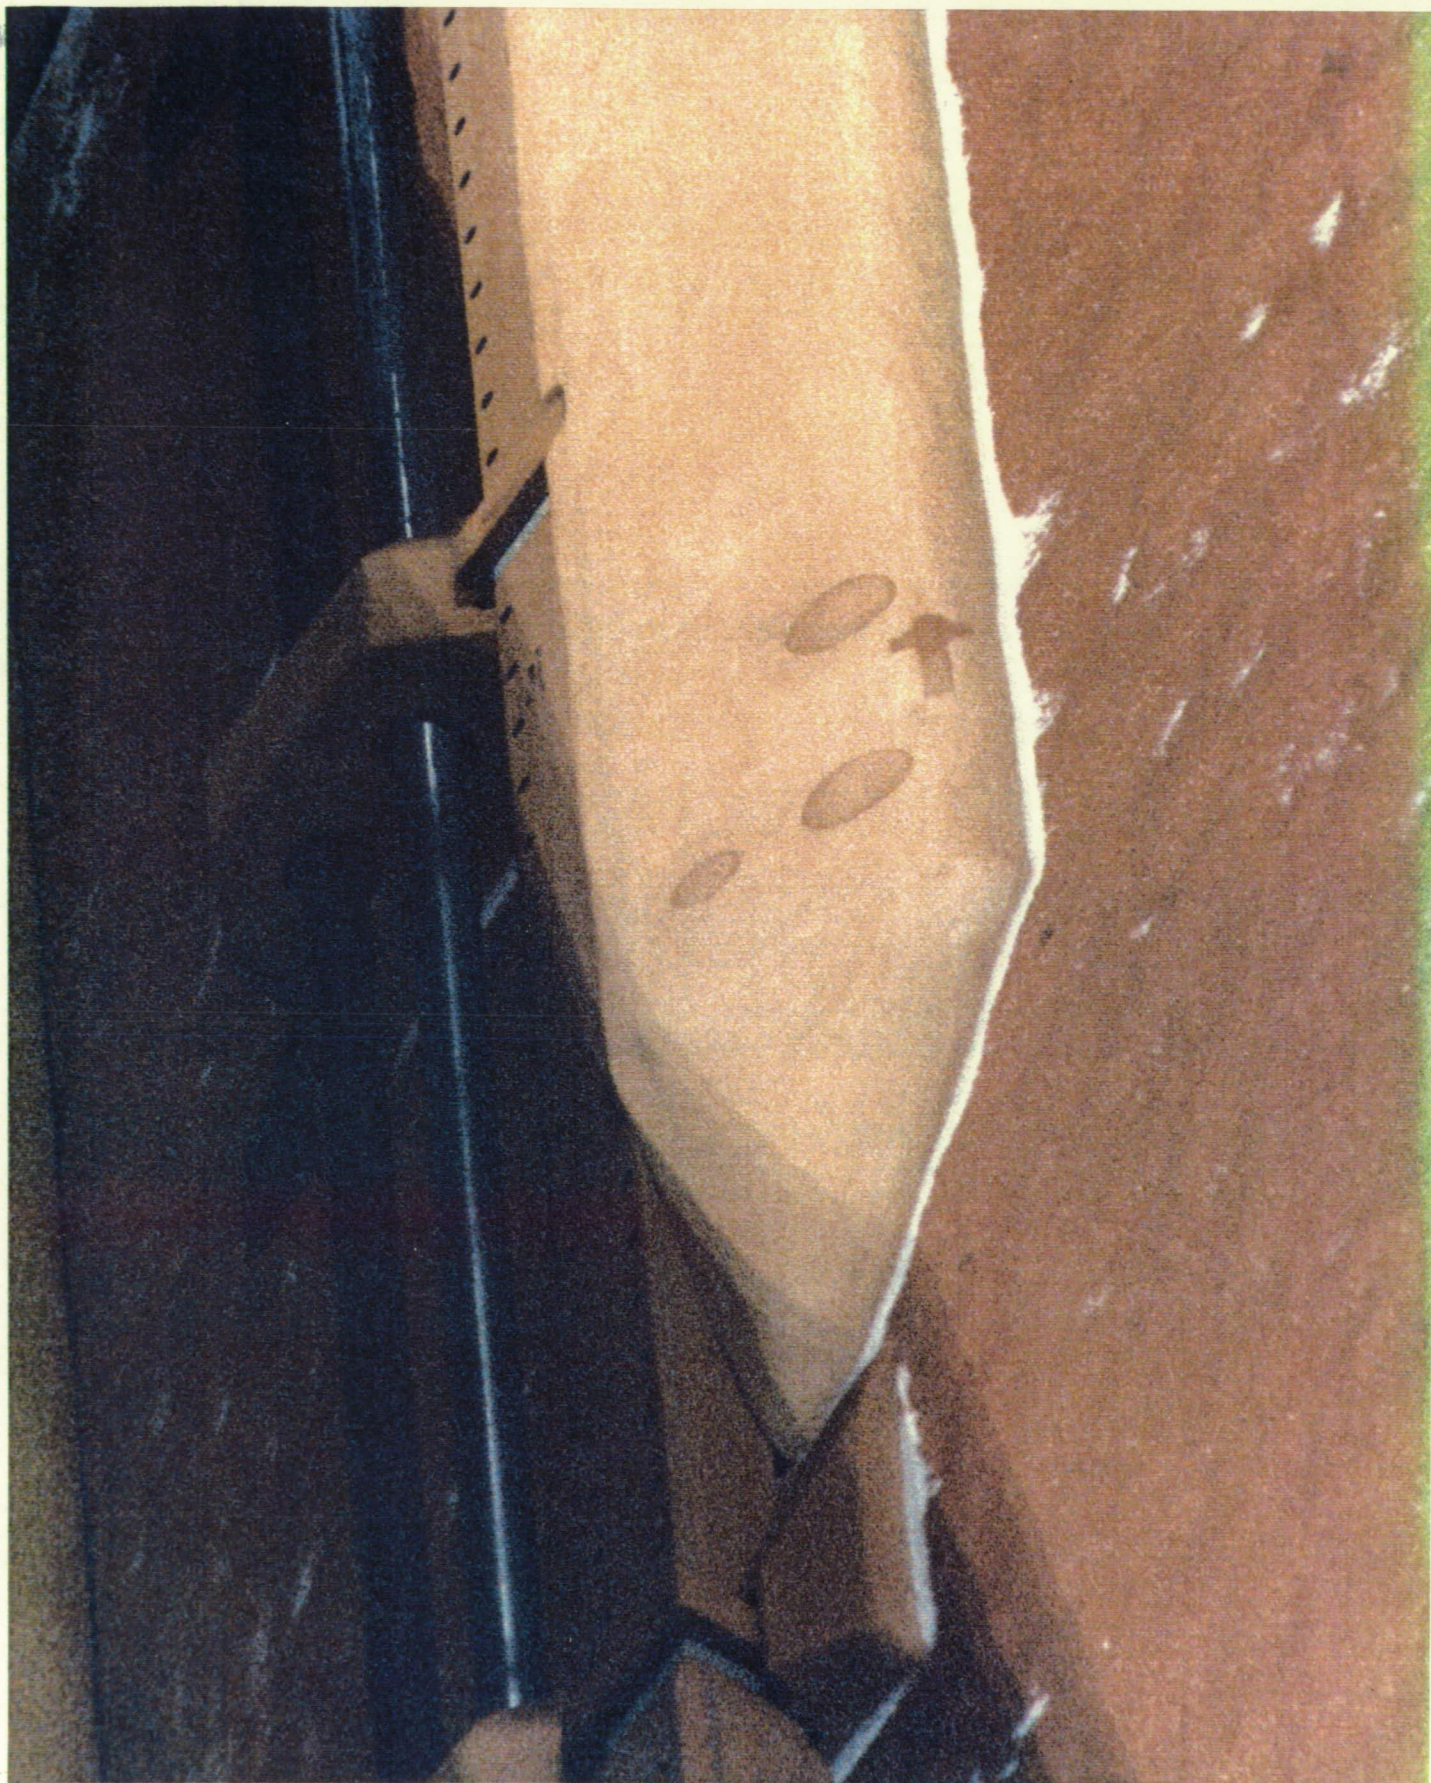
Ice/frost accumulations along the PAL ramp, cable tray ramps, pressurization line supports, and on the LH2 tank TPS acreage had melted prior to launch.

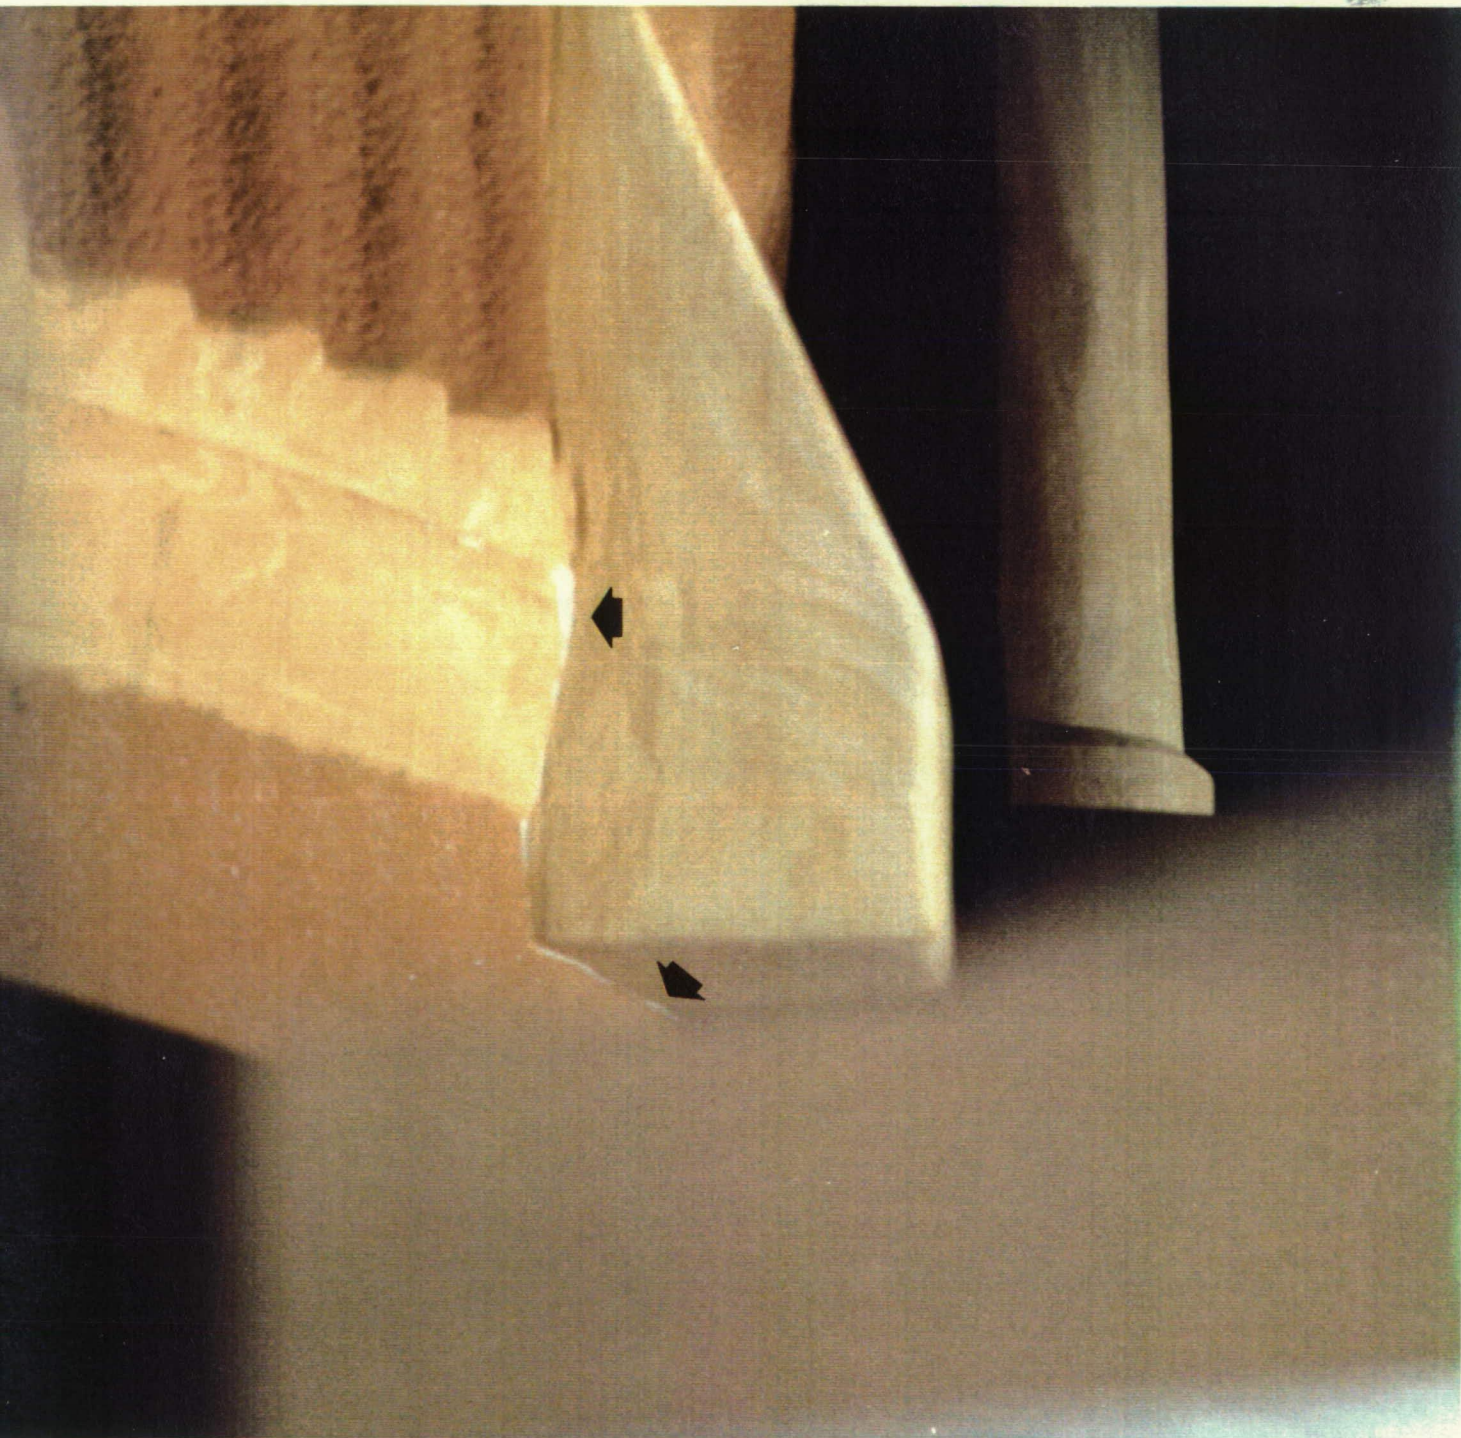
Ice/frost formation along the -Y bipod ramp closeout outboard and aft bondline was acceptable per the NSTS-08303 criteria.

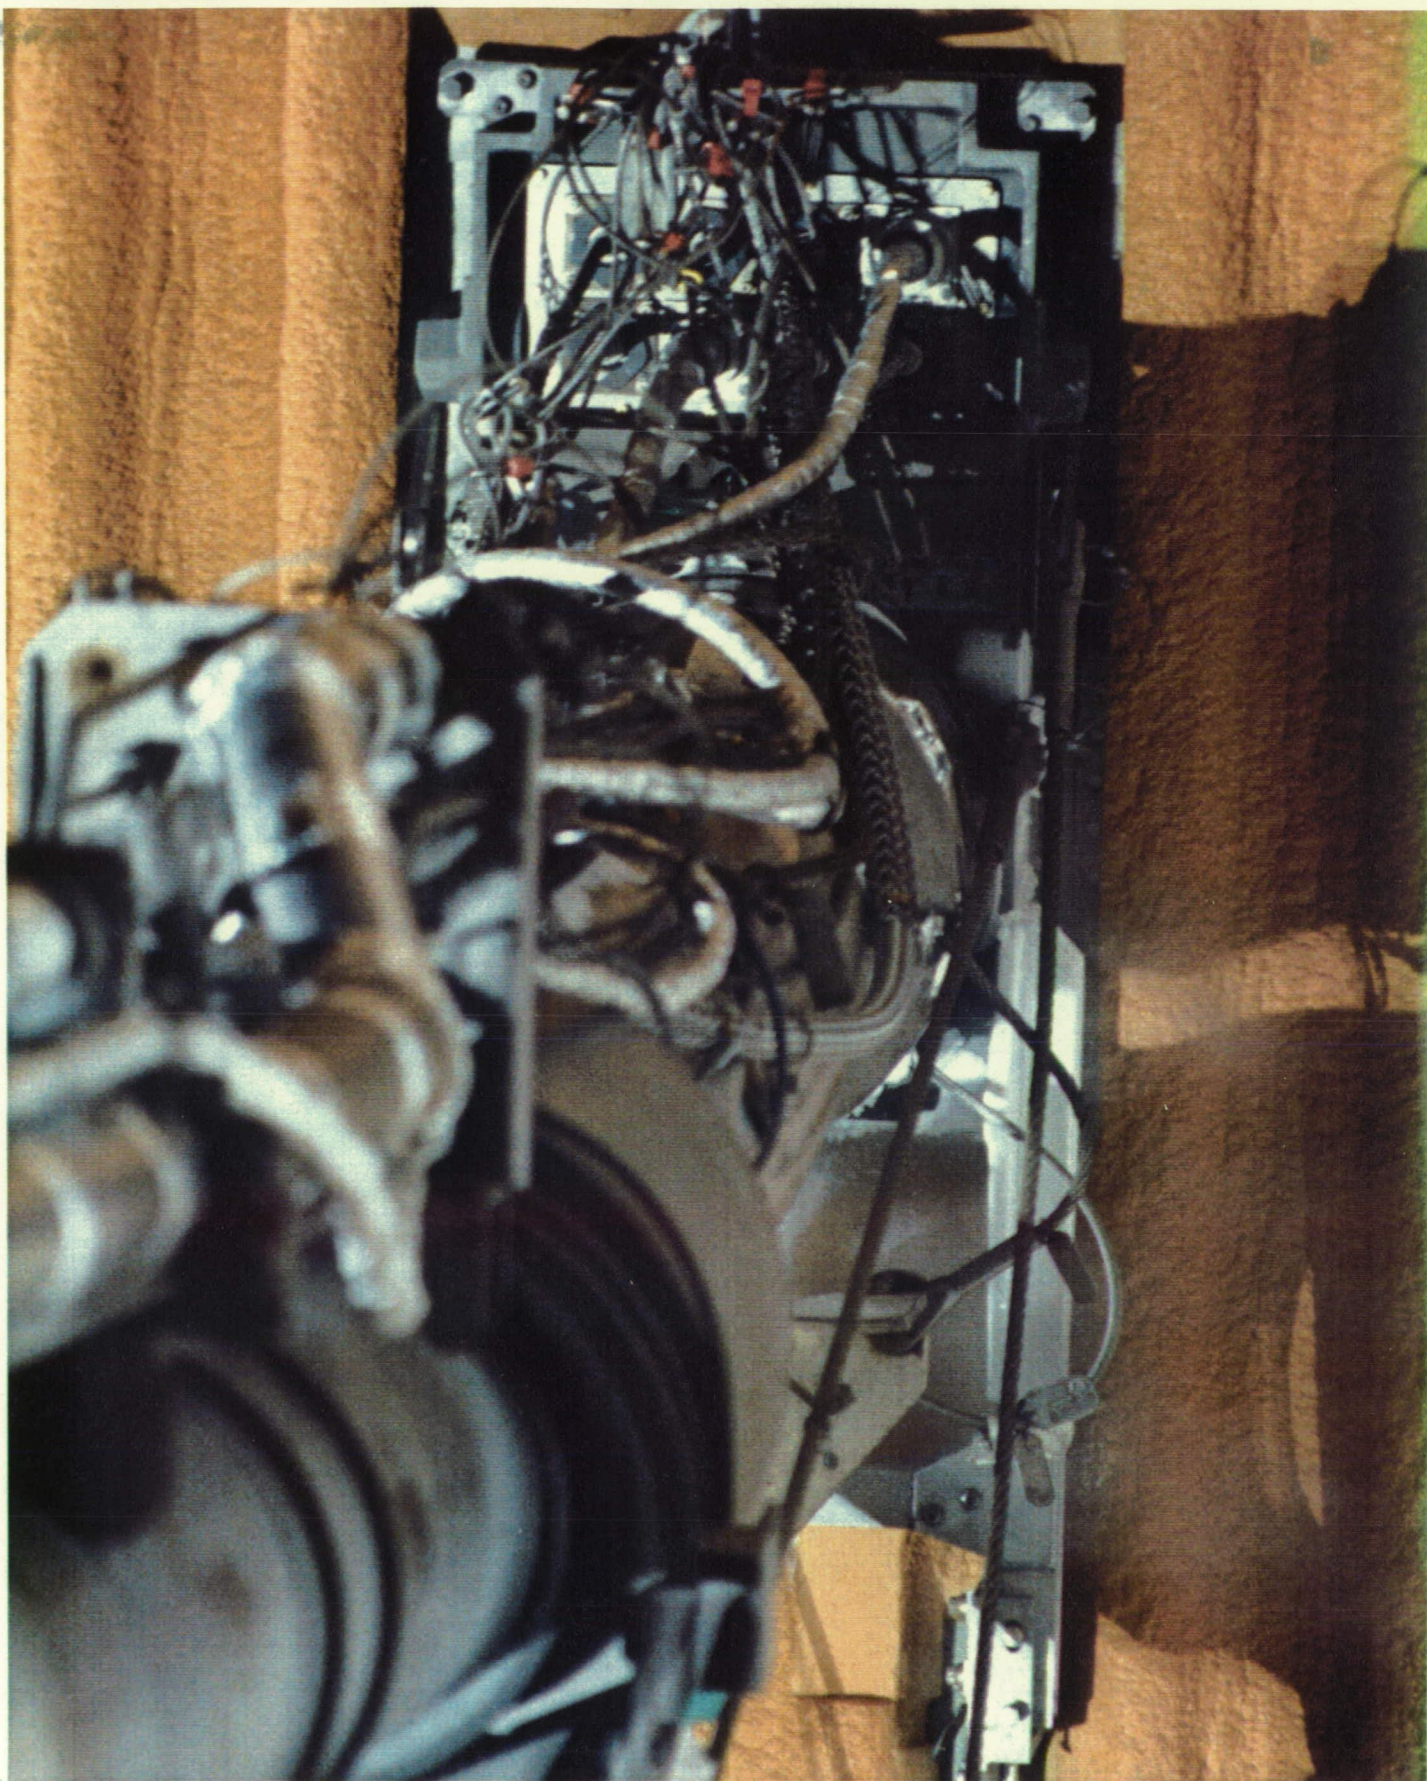
There was no apparent leakage at the GUCP. As expected, ice/frost had formed on the GUCP legs and on the uninsulated parts of the umbilical carrier plate.

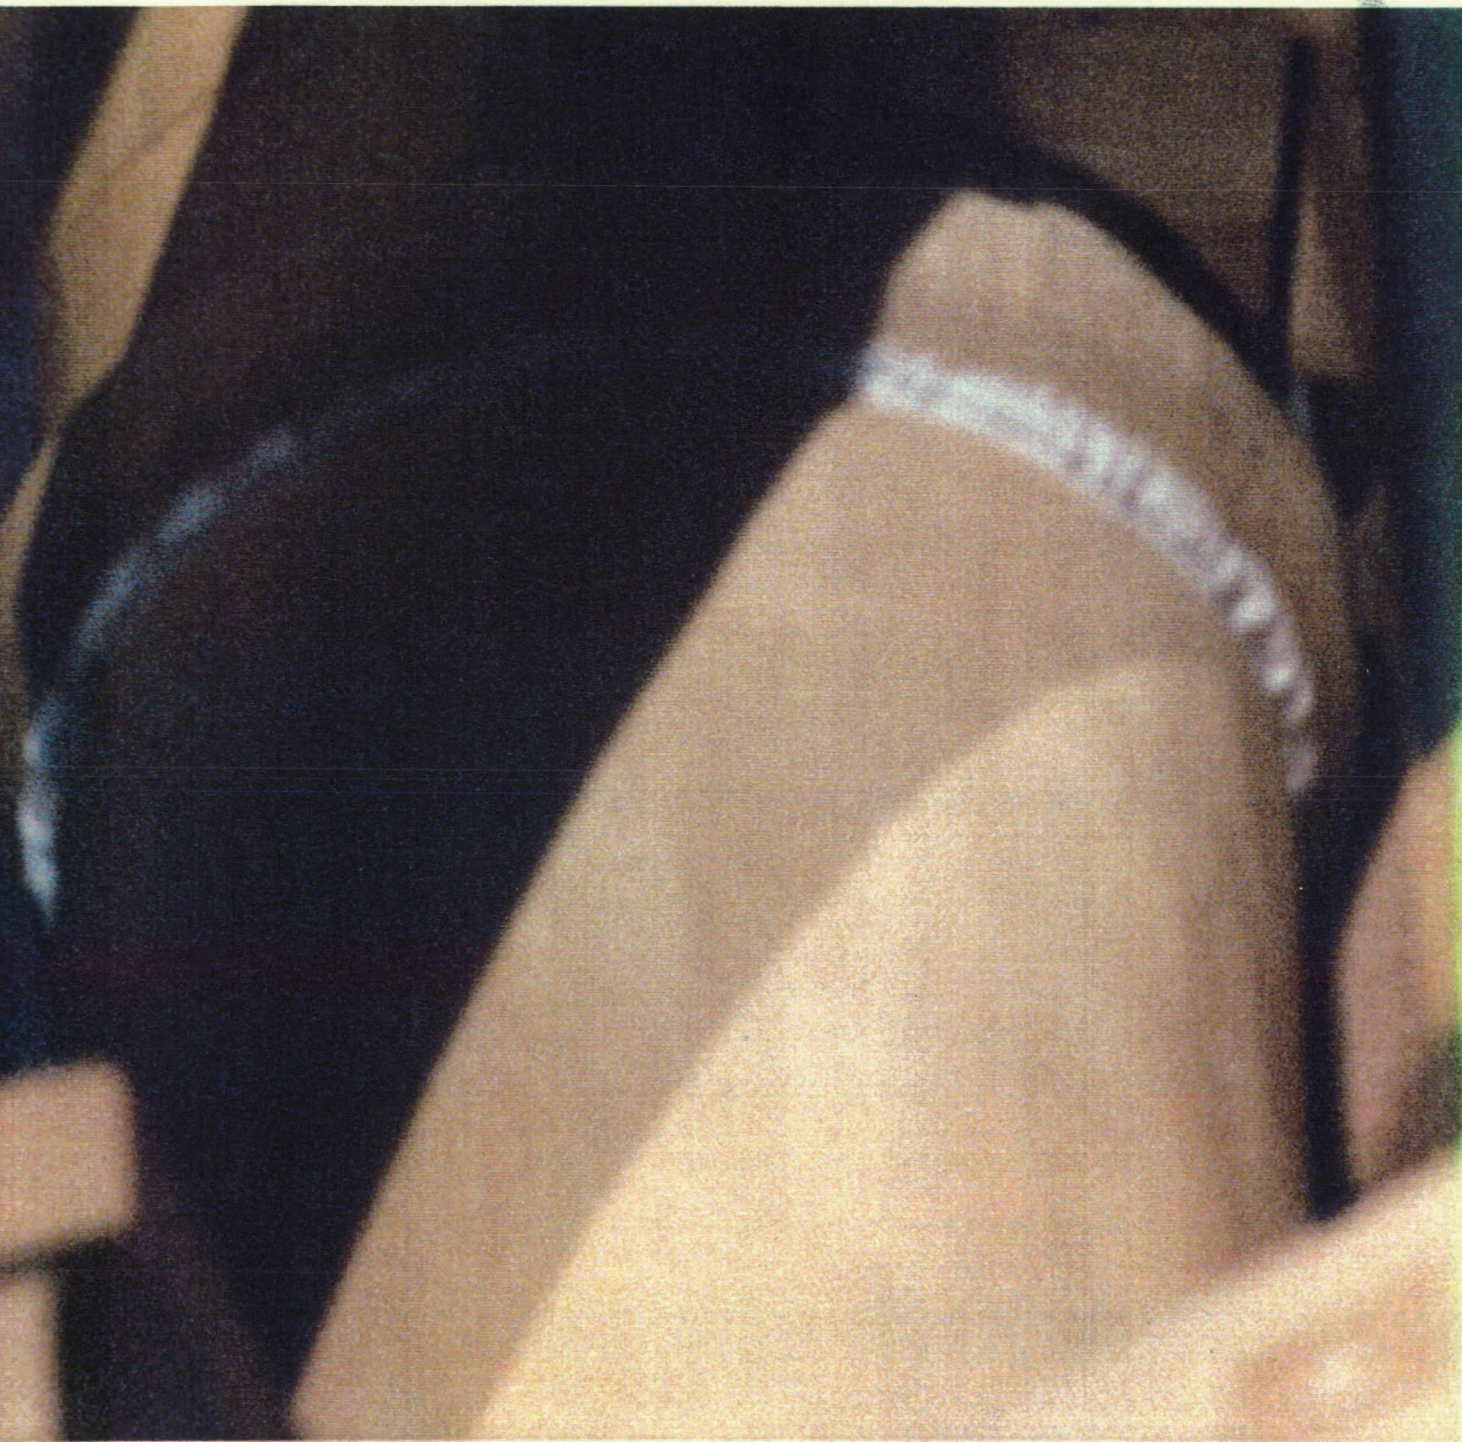
Crusty, somewhat denser than usual ice/frost had formed in the L02 feedline bellows. Although the amounts of ice/frost in the bellows were slightly greater than usual, the accumulations were acceptable per the NSTS-08303 criteria.
